INDEPENDENT JAPAN AUCTION INSPECTION

AUCTION	MIRIVE Saitama
LOT	11059
VEHICLE	2019 Toyota Alphard
COLOUR	Black
ODOMETER	~86,000 km
INSPECTED	25 Oct 2026
REPORT ID	RPT-08304-20261025

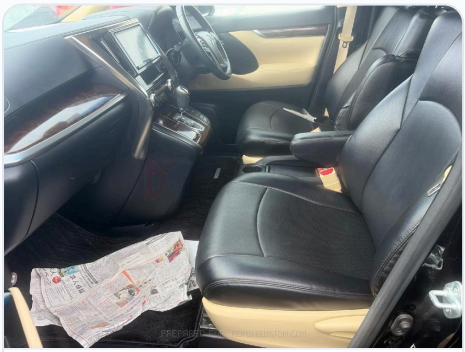
3 / 4

Seat covers are fitted to all seats. The driver's seat cover is split. No stains or burns were found on the covers; the seats underneath could not be seen. SEE F-03

Seat covers are fitted to all seats. The driver's seat cover is split. No stains or burns were found on the covers; the seats underneath could not be seen.

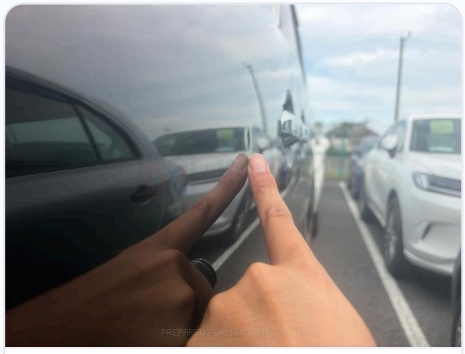
4 / 11

Small dents on the bonnet and on the side doors, a small mark on the front bumper beside the fog lamp, a dent in the lower window trim, scratches along the lower doors, and dull, marked paint on the roof. The repair on the left rear door and quarter panel is graded under the repaired-panels question (Major). SEE F-05

Small dents on the bonnet and on the side doors, a small mark on the front bumper beside the fog lamp, a dent in the lower window trim, scratches along the lower doors, and dull, marked paint on the roof. The repair on the left rear door and quarter panel is graded under the repaired-panels question (Major).
